**Regency Silver drills third hole into broad zones
of sulphide-specularite bearing mineralization
Drilling ongoing**

Vancouver, BC – February 4, 2026 – Regency Silver Corp. (“Regency Silver” or the “Company”, TSXV-RSMX : OTCQB-RSMXF : Frankfurt- ZJ90) is pleased to announce that the second hole of its ongoing 2026 drill program at its Dios Padre project in Sonora, Mexico has intersected sulphide-specularite bearing breccia and vein-infill in multiple zones across a broad interval (Figure 1). Hole REG-26-28 was drilled ~75m below Hole REG 25-26 and intersected broad mineralization from ~430m to ~540m. A breccia zone with chalcopyrite, pyrite and specularite with intense silica-sericite alteration is intersected from ~500m to ~535m. The core zone is ~ 180m to the south of a similar breccia intersected in REG-25-25 (See news release dated [December 8, 2025](#)). Previously drilled holes REG-23-21 yielded **38m of 7.36 g/t** gold, REG-22-01 yielded **35.8** metres of **6.84 g/t** gold, **0.88%** copper and **21.82 g/t** silver, and REG-23-14 yielded **29.4 m of 6.32 g/t** gold.

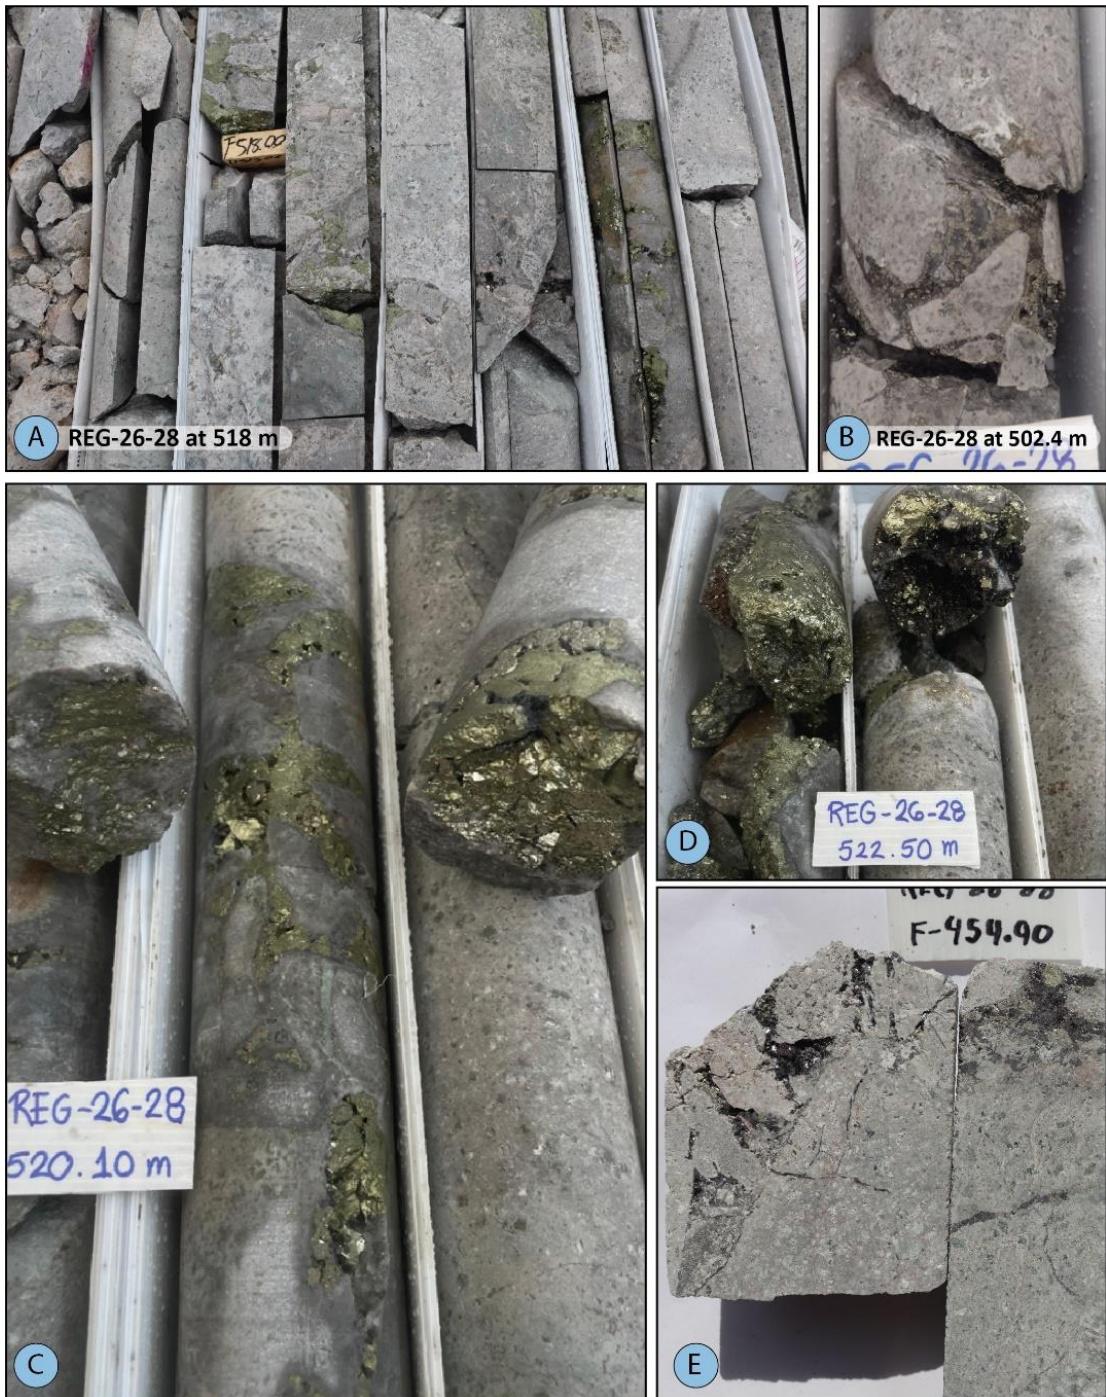
Figure 1: Selection of photographs of the sulphide-specularite infilled breccias from REG-26-28.

“The visual results from REG-26-28 further demonstrate the continuity and scale of the Dios Padre breccia system. Intersecting multiple zones of sulphide-specularite mineralization at depth strengthens our confidence that this system widens below historic workings. These observations continue to support the significant upside potential of the project as we advance our 2026 drill program” said Bruce Bragagnolo, CEO.

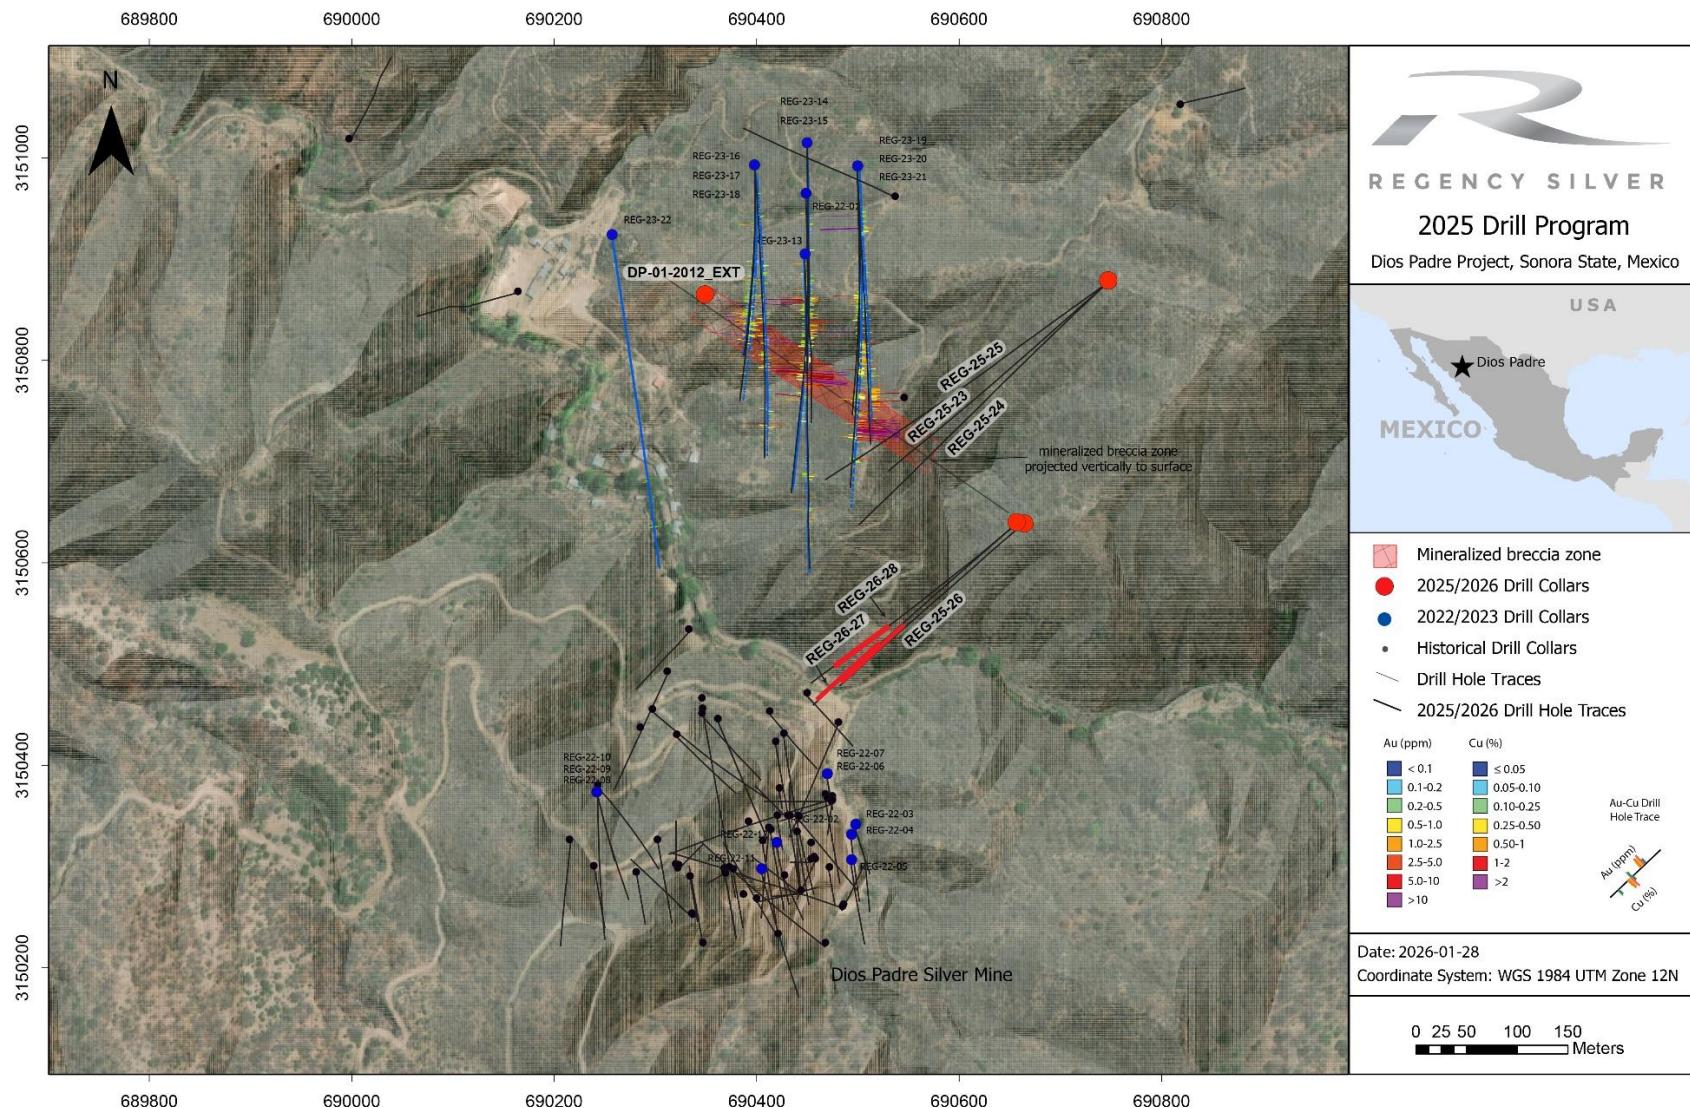
Figure 2: Plan map with hole traces for current and historic holes. Dios Padre deep breccia in red is projected vertically to surface. Red trace on REG-26-28, REG-26-27, and REG-25-26 is the vertical projection of the non-continuous zone of sulphide-specularite mineralization to surface.

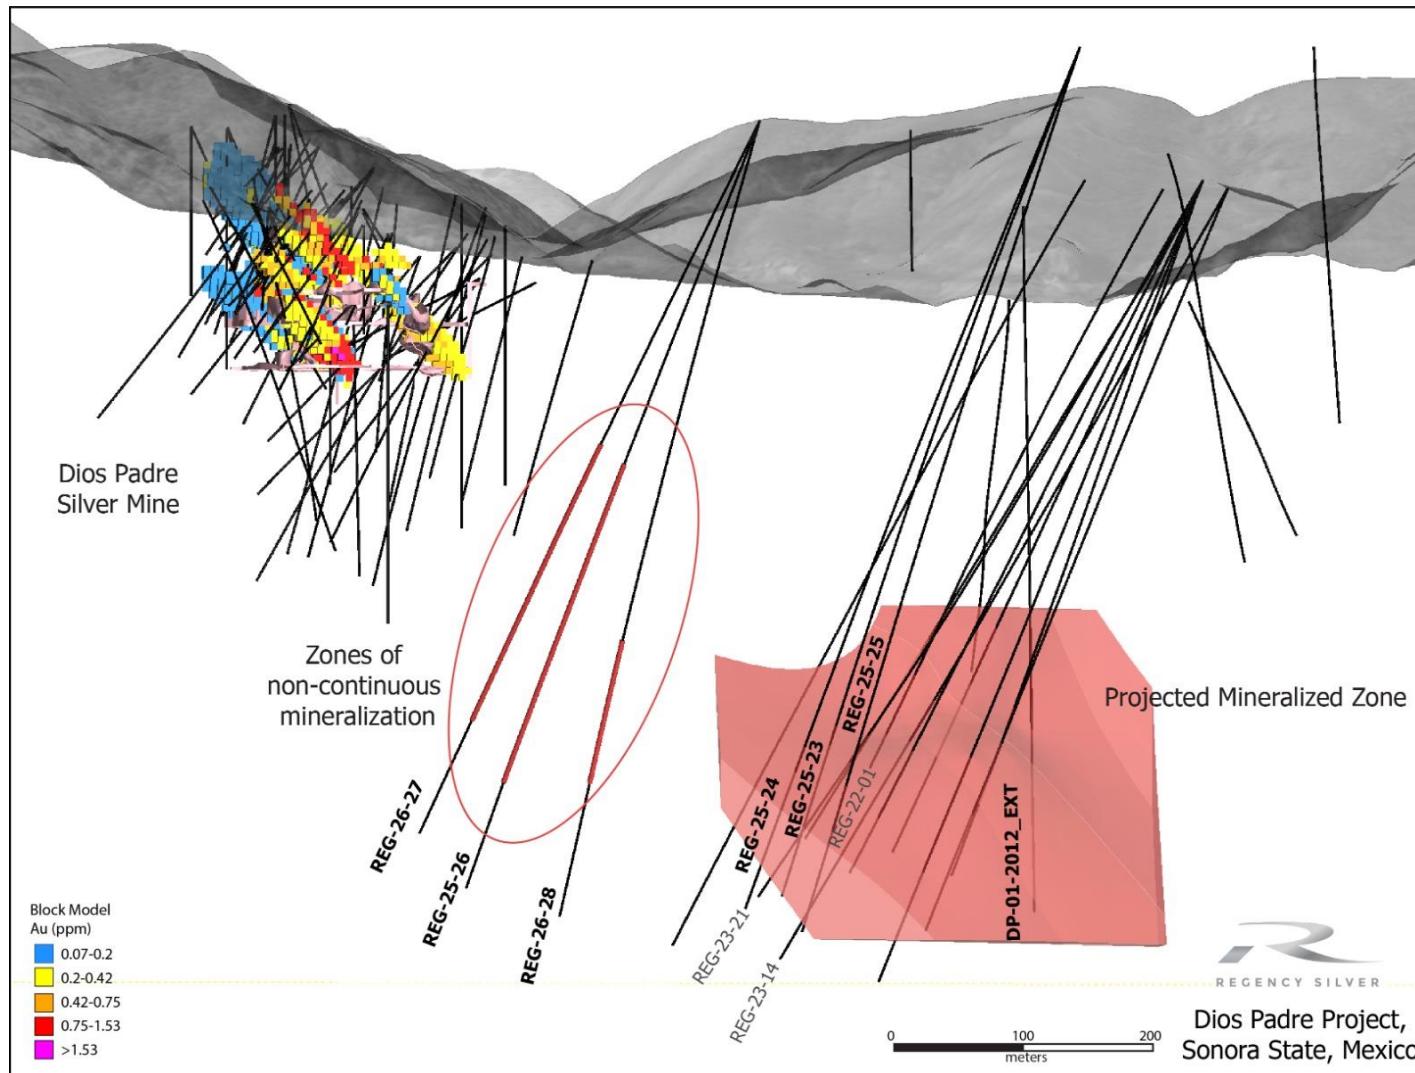
Figure 3: 3D slice through the Dios Padre drilling area looking west. Dios Padre breccia zone (Red- projected) and the drill hole traces with block model and historic mine workings of historic silver mine. Red bars on drill traces indicate broad zones of non-continuous sulphide-specularite mineralization.
